MOVE®
TECHNICAL SHEET

PERGOTENDA® MOVE is a retractable covering system custom made to protect against sun and rain (not suitable to support snow), fixed to a supporting wall. It consists of an aluminium structure and a folding canvas.

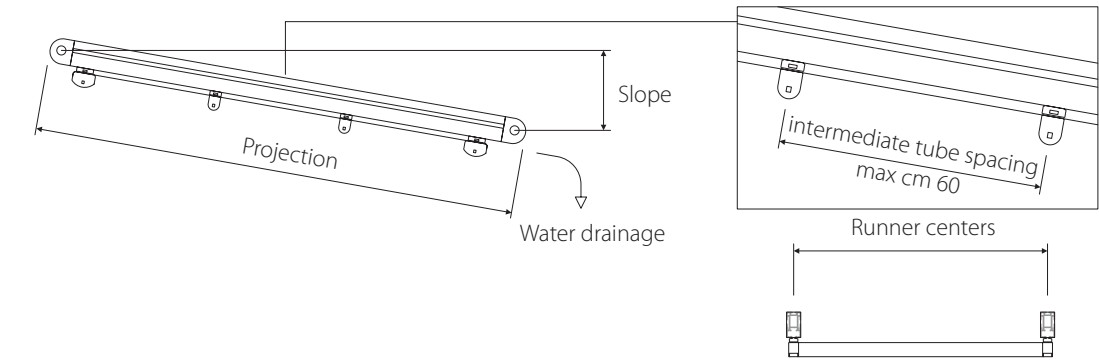
MINIMUM SLOPE TILTED VERSIONS

Taut canvas when system is open. Frontal rainwater drainage.

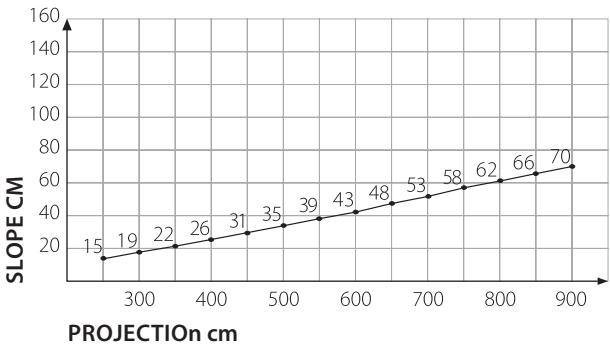
Runner centers 200 cm (slope 6-7,8%)

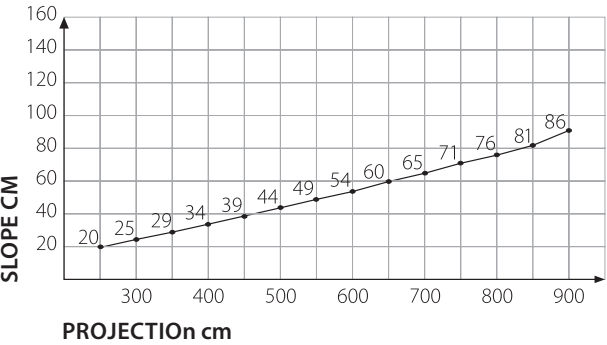
Runner centers 250 cm (slope 8-9,5%)

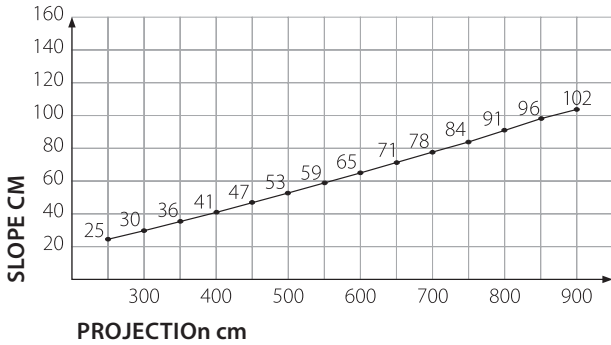
Runner centers 300 cm (slope 10-11,3%)

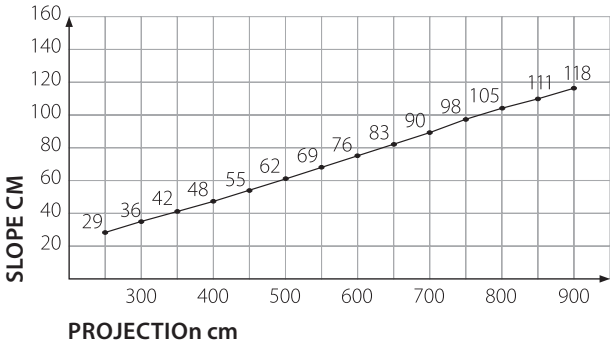
Runner centers 350 cm (slope 11,6-13,1%)

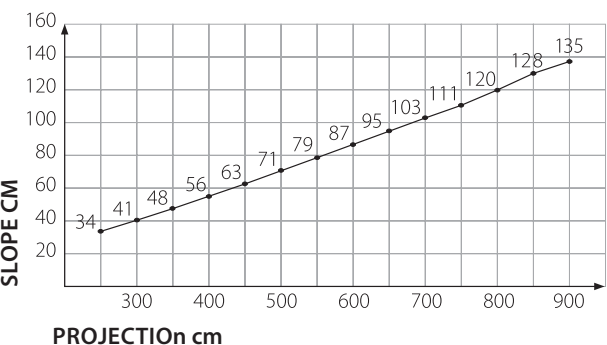
Runner centers 400 cm (slope 13,6-15%)

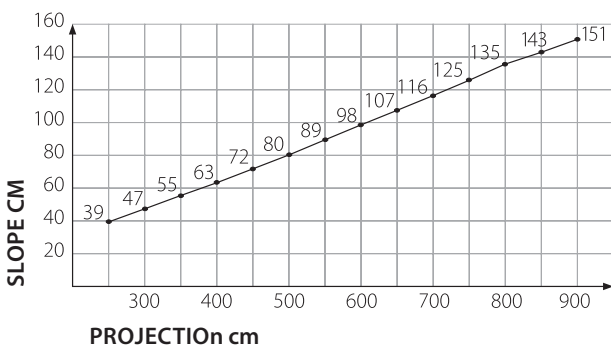
Runner centers 450 cm (slope 15,6-16,8%)

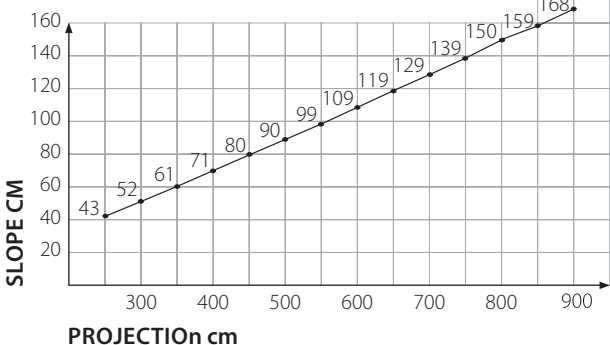
Runner centers 500 cm (slope 17,2-18,7%)

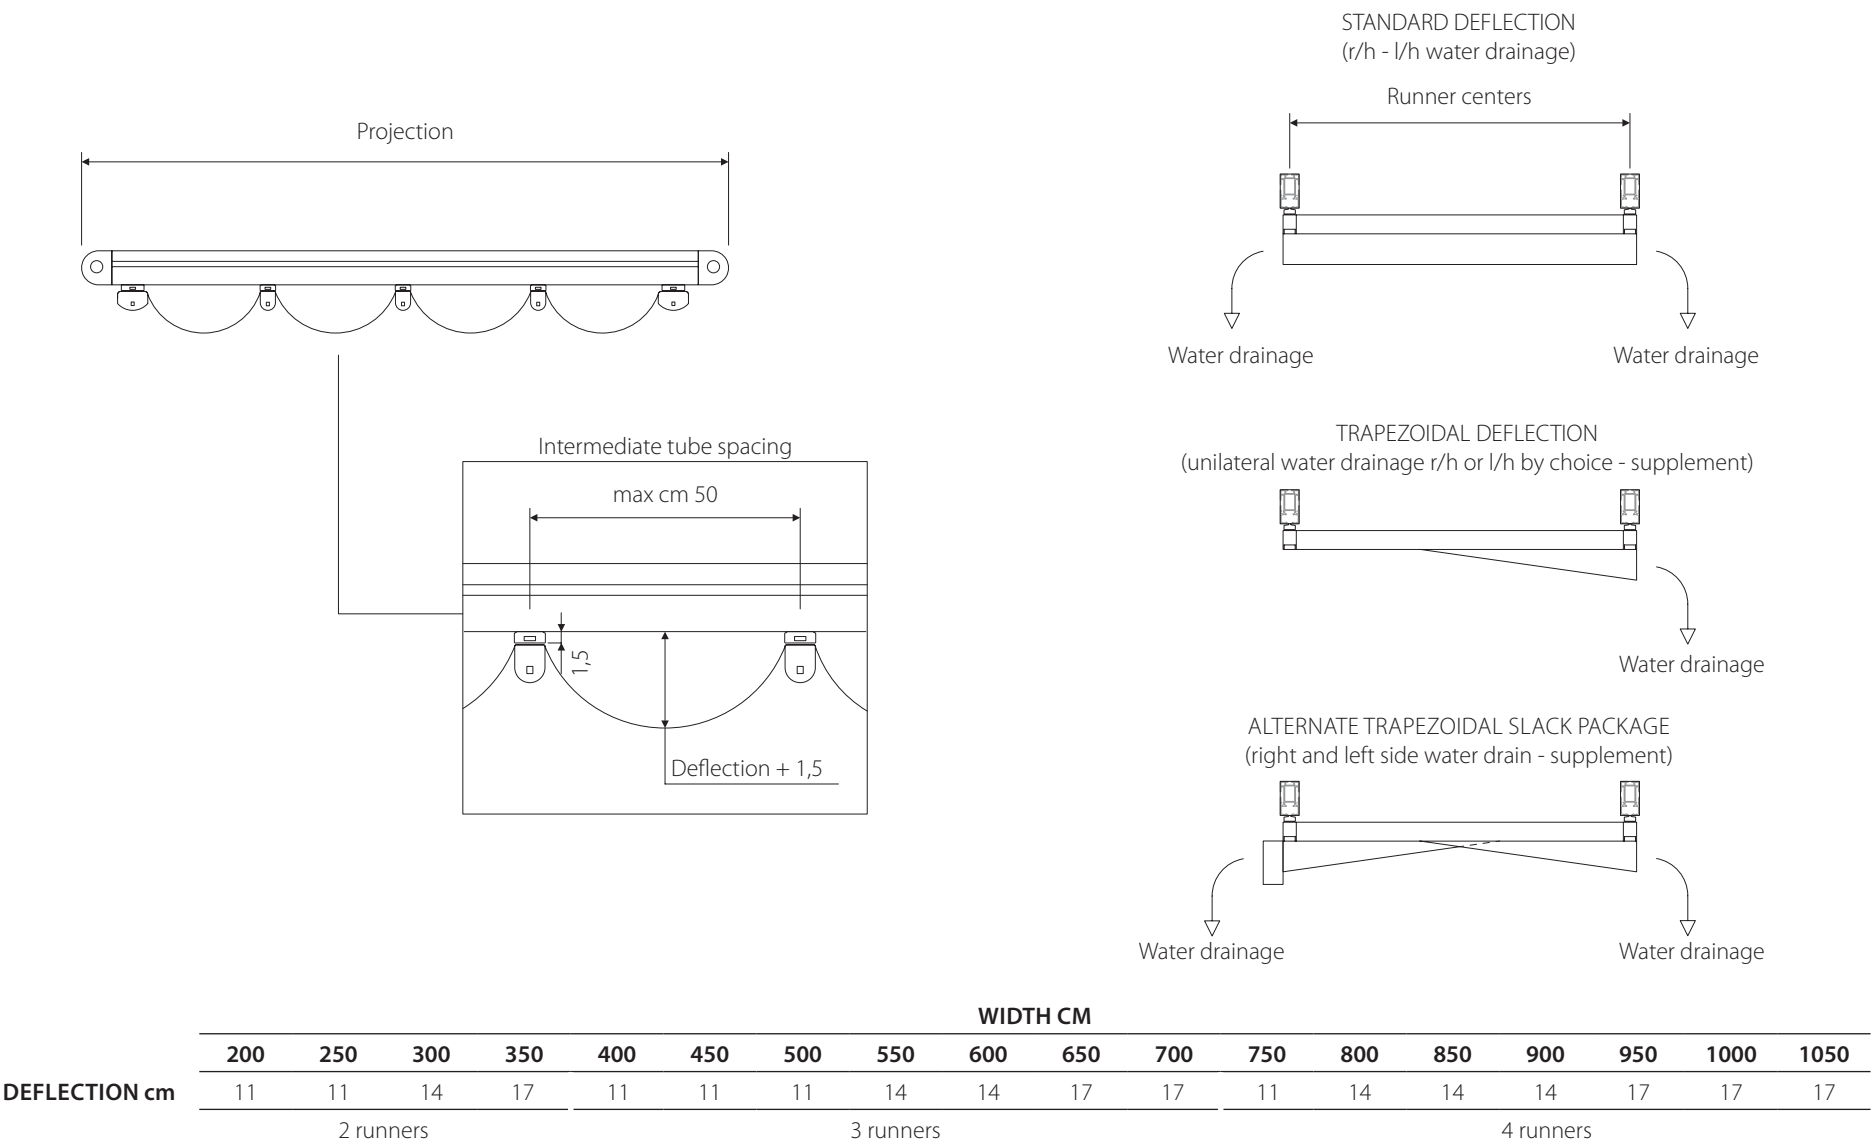
DEFLECTIONS FLAT VERSIONS

Slack canvas when system is open. Lateral rainwater drainage.
The rainwater drainage may be unilateral when a trapezoidal canvas is used.

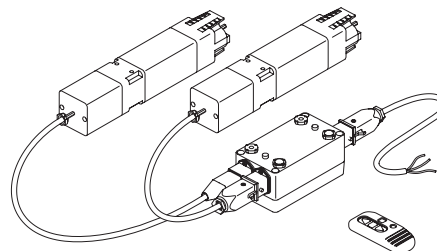
ELECTRIC DRIVE TYPE 2

220 volt / 218 watt motor reducer with encoder and microchip that controls the canvas tension, guarantees constant correct tension despite size variations caused by differing environmental circumstances, with radio command (433.92 MHz) and 1 channel transmitter. Required for 2 or 3-runners awning, tilted version.

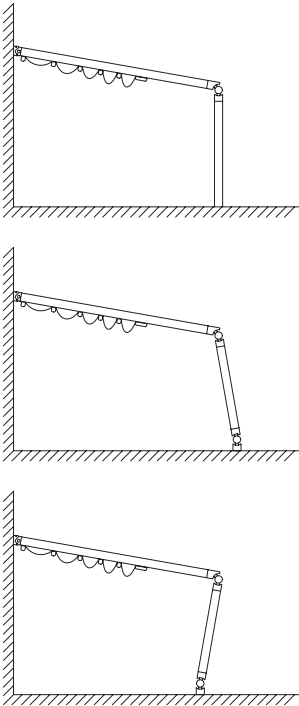
TILTED
Version

MAXIMUM DIMENSIONS cm		
	Width	Projection
2 runners	400	650
3 runners	800	650
4 runners	1200	650

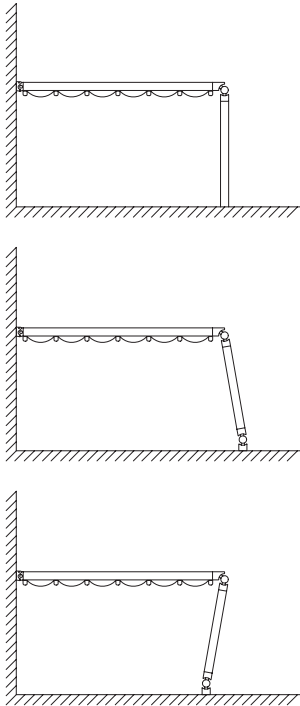
FLAT
Version

MAXIMUM DIMENSIONS cm		
	Width	Projection
2 runners	400	650
3 runners	800	650
4 runners	1200	650

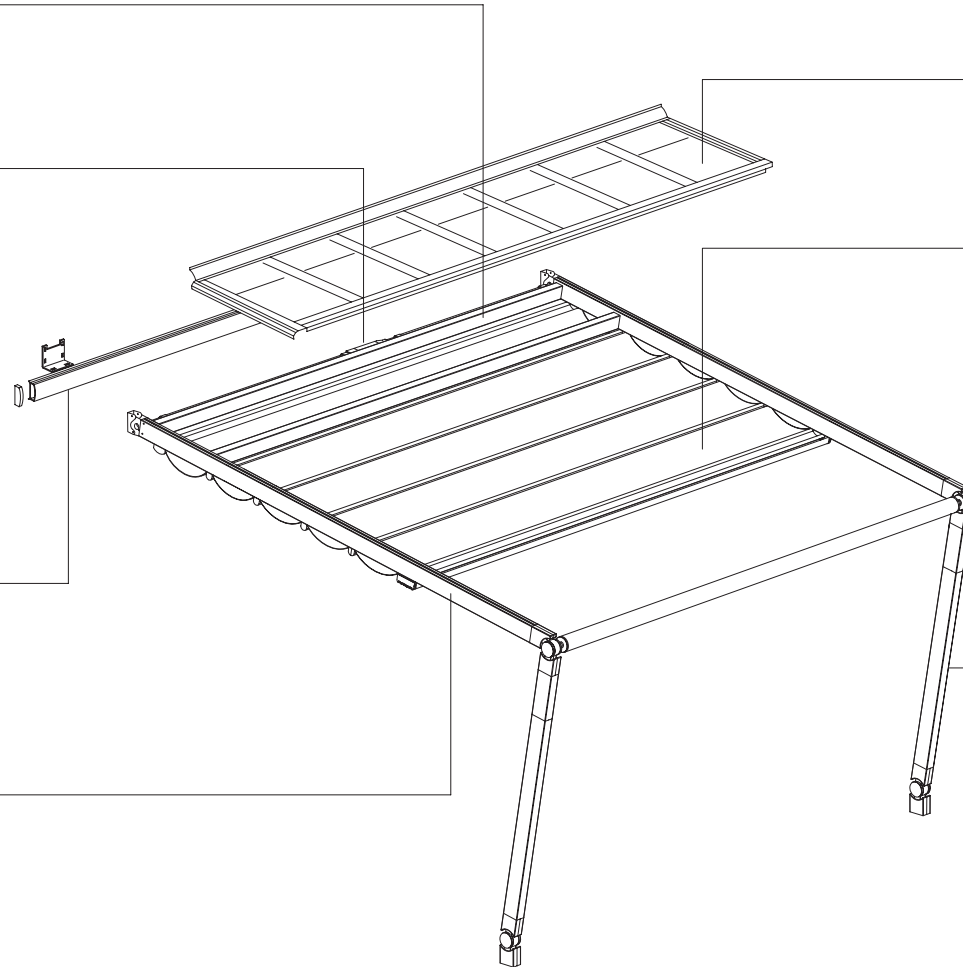
PERGOTENDA® MOVE 2 RUNNERS

crossbar 4x10 for protection cover support

electric drive

modular awning protection cover

canvas

wall beam (supplement)

supporting runner 6x12

pillar 7x12

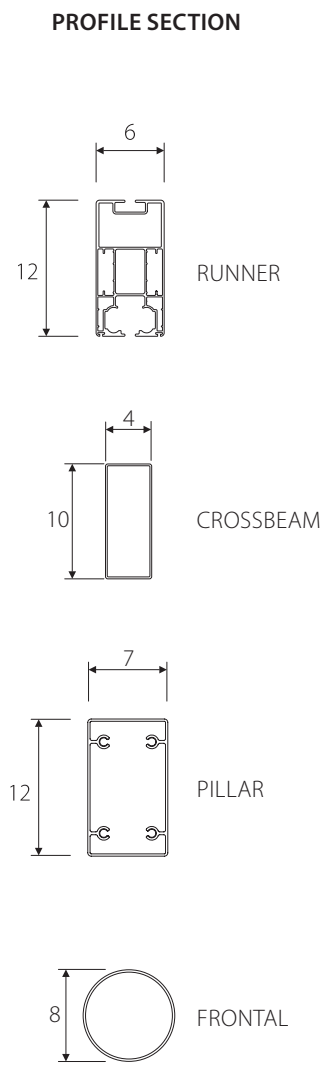
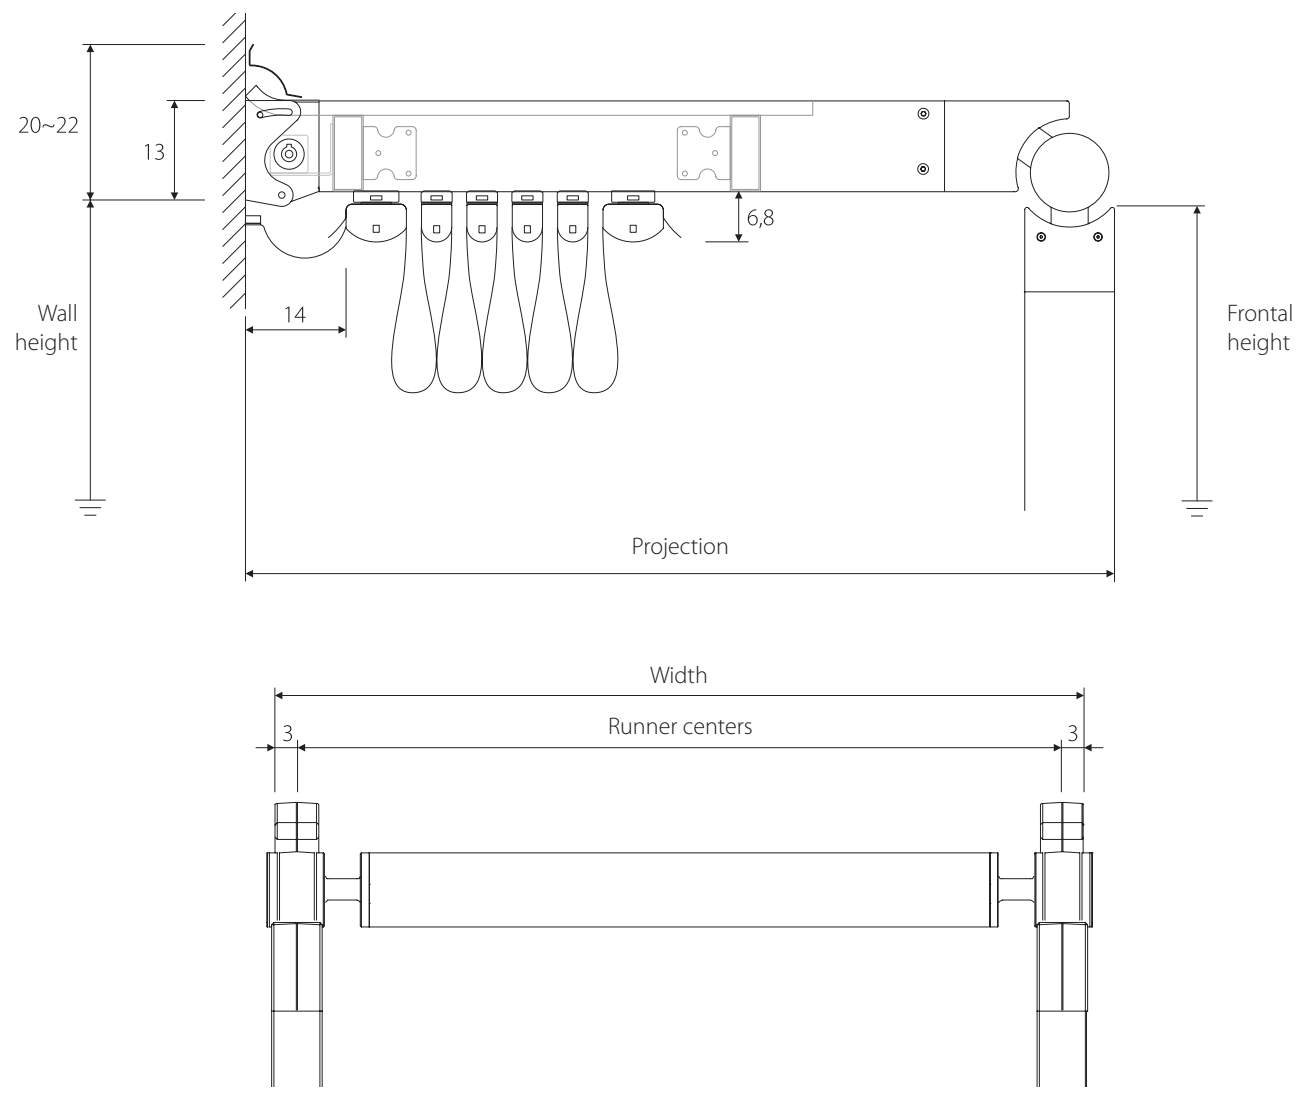
PERGOTENDA® MOVE DIMENSIONS

All measurements are given in cm.

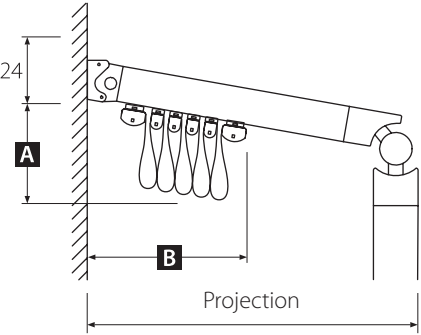
Tilted version

Minimum values of the encumbrance of the folded awning for the tilted version (slope 15%). The figures written in bold type refer to the canvas encumbrance with standard support tubes and the following refer to the use of additional tubes.

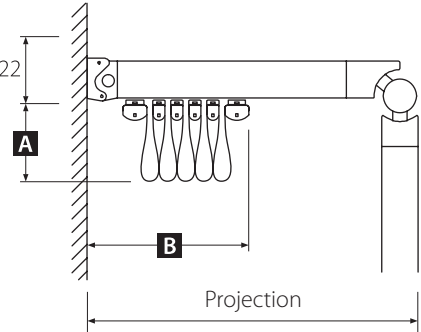
Flat version

Minimum values of the encumbrance of the folded awning for the flat version. The figures written in bold type refer to the canvas encumbrance with standard support tubes with a deflection of 17 cm.

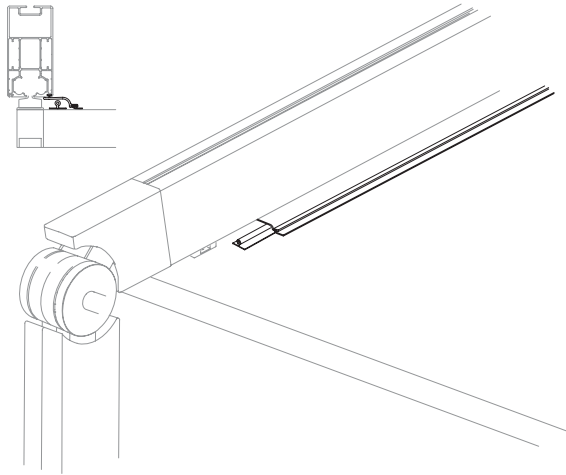
S1 Antidrop system + Antispray profile

Weldable PVC profile on the upper part of the canvas for lateral rainwater prevention complete with antispray profile PERGOTENDA® IRIDIUM® preassembled on runners.

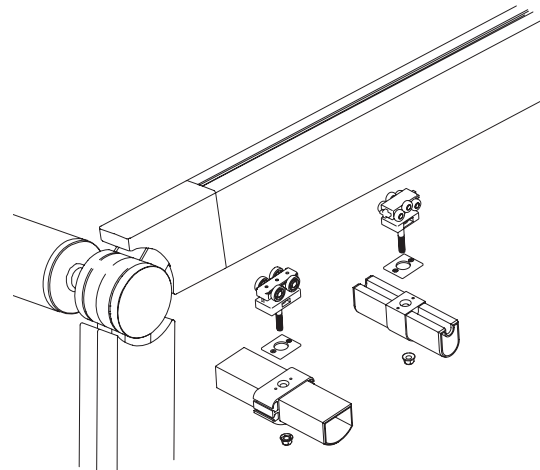
S4 Add-on runner

Runner PERGOTENDA® IRIDIUM® completa di pillar 6x12, supporti inox, carrelli, giunzioni tubi, albero centrale di trasmissione con relativi anelli di fermo.

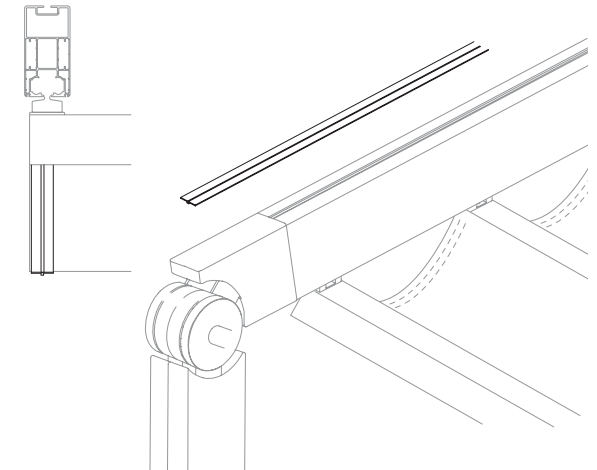
S18 Underside drip-collection rim (flat versions)

Welded PVC profile on the underside of the canvas. Solely for canvases in the suggested configuration.

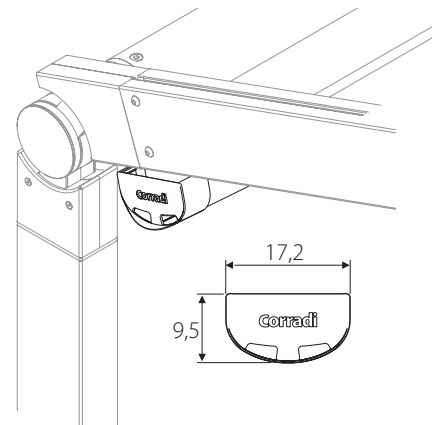
S6 Retractable gutter

Extruded aluminum profile for rainwater collection, only for pitched versions, fixed to the end support tube. One drainage per runner.

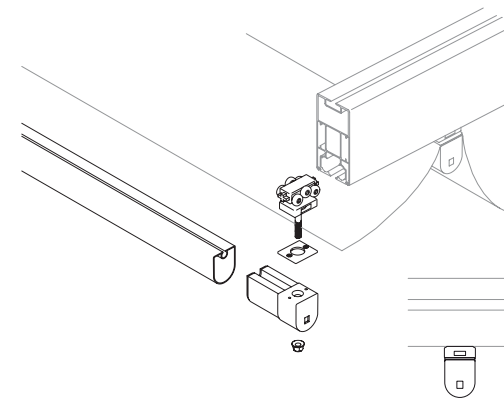
S5 Add-on intermediate support tube

Complete intermediate support tube with endcaps, joints (where present) and intermediate sliders.

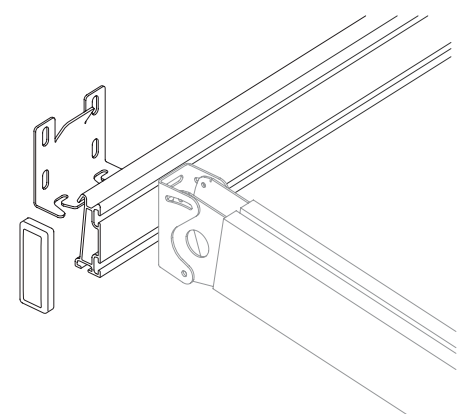
S17 Trave wall beam

Aluminum profile for uneven walls, where standard fastening to supports is awkward; or otherwise to deal with minor bumps.

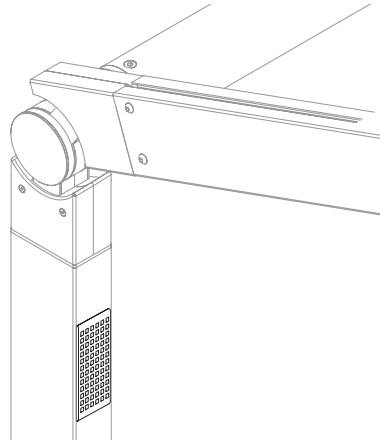
Sound diffuser

Sound diffusers (medium+high), max power 60W, wired into each pillar and set up to connect to existing Hi-fi systems.

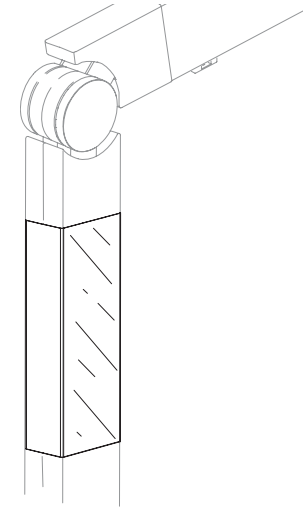
RGB LED lamp

RGB LED dimmer lamp adjustable via remote control; pre-mounted in each pillar. 2000 lumen.

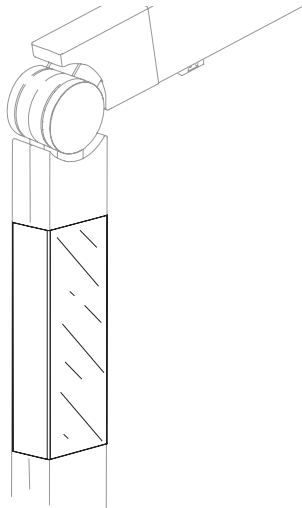
White LED lamp

White LED dimmer lamp adjustable via remote control; pre-mounted in each pillar. 2000 lumen.
